Manhole Inspection Summary

Manhole # S39C__031MH

Insp Date: **1/15/08 2:01 PM**

Location Address: **226 st matthew st**

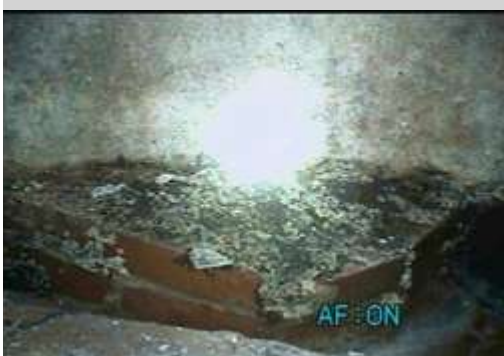
misc

bench debris

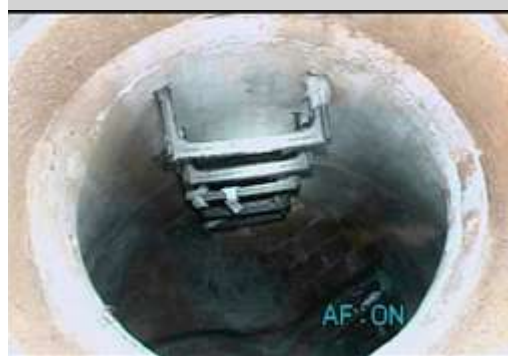
Defect 2

☒ **Evidence Of Surcharge**

Depth: **2.** (ft.) ☐ Active Surcharge Present

evidence of surcharge

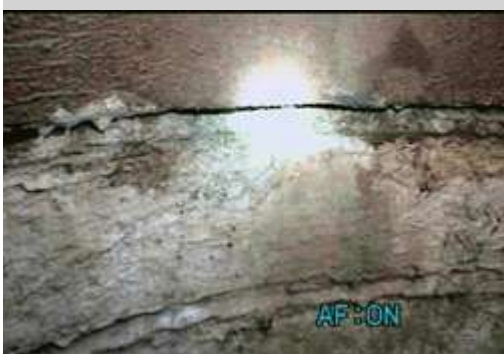
Defect 1

Condition: ☐ Sound ☒ **Cracked** ☐ Root Intrusion ☐ Loose Brick ☐ Deteriorated

Chimney cracked
frame adj

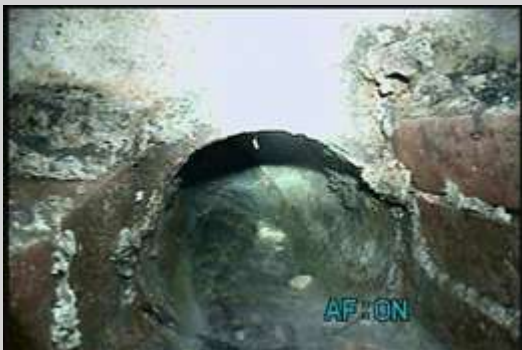
12 O'Clock Outflow

6 in. Circular Gravity Sewer
Pipe Out @ 12 O'Clock

Deposits: ☐ None ☐ Mud ☒ Gravy ☐ Debris ☐ Grease

Silt Depth: 2 (in.) Deposits Extent: Medium

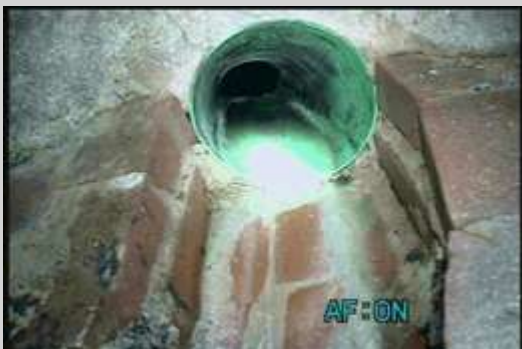
3 O'Clock Inflow

6 in. Circular Gravity Sewer
Pipe In @ 3 O'Clock

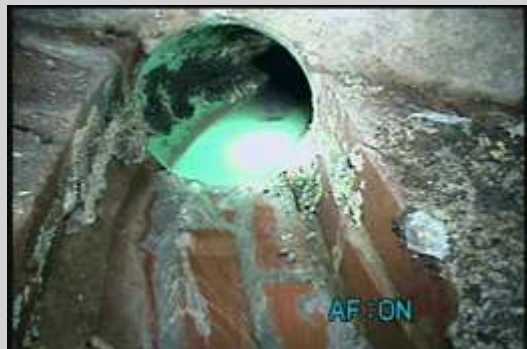
9 O'Clock Inflow

6 in. Circular Gravity Sewer
Pipe In @ 9 O'Clock

Deposits: ☐ None ☐ Mud ☒ **Sludge** ☐ Debris ☐ Grease

Silt Depth: **1** (in.) Deposits Extent: **Medium**
